Home Report

11 Balmossie Avenue
Monifieth Dundee DD5 4QN

Single Survey

Property Address	11 Balmossie Avenue Monifieth Dundee DD5 4QN
Customer	Executors of Margaret McNaughton
Prepared by	Graham + Sibbald Property Consultants Limited
Date of Inspection	06/07/2026

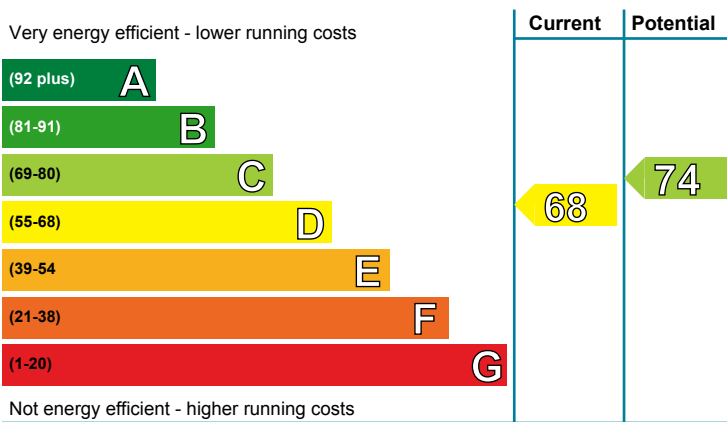
Energy Efficiency Rating

This graph shows the current efficiency of your home, taking into account both energy efficiency and fuel costs. The higher this rating, the lower your fuel bills are likely to be.

Your current rating is **band D (68)**. The average rating for EPCs in Scotland is **band D (61)**.

The potential rating shows the effect of undertaking all of the improvement measures listed within your recommendations report.
