# Home Report

# Scottish Single Survey

<b>Property address</b>	1/R 48 Cleghorn Street Dundee DD2 2NJ
<b>Customer</b>	Donald Maclean
<b>Customer address</b>	
<b>Prepared by</b>	Shepherd Chartered Surveyors
<b>Date of inspection</b>	22/06/2026

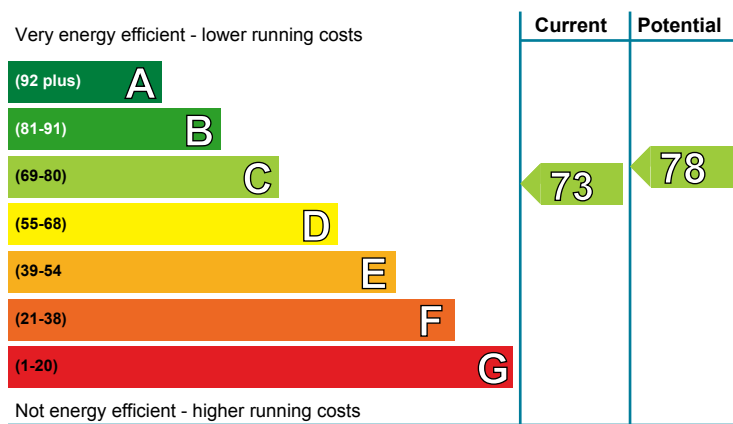
## Energy Efficiency Rating

This graph shows the current efficiency of your home, taking into account both energy efficiency and fuel costs. The higher this rating, the lower your fuel bills are likely to be.

Your current rating is **band C (73)**. The average rating for EPCs in Scotland is **band D (61)**.

The potential rating shows the effect of undertaking all of the improvement measures listed within your recommendations report.

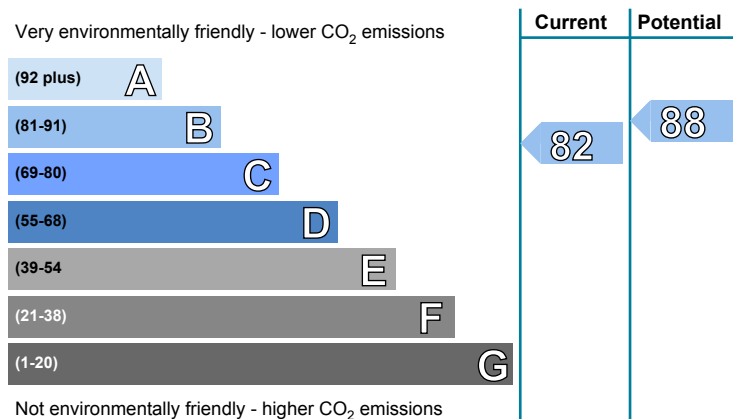
## Environmental Impact (CO<sub>2</sub>) Rating

This graph shows the effect of your home on the environment in terms of carbon dioxide (CO<sub>2</sub>) emissions. The higher the rating, the less impact it has on the environment.
